Manhole Inspection Summary

Manhole # S15CC_013MH

Insp Date: **7/30/09 12:09 PM**

Location Address: **1100 CLAYMONT AVE**

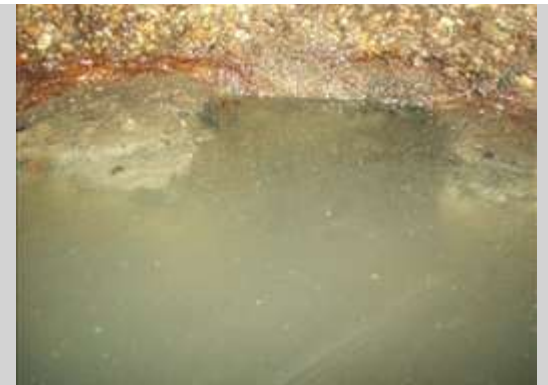
3 O'Clock Inflow

8 in. Circular Gravity Sewer
Pipe In @ 3 O'Clock

Pipe Height: (in.) Direct
Pipe Material: **Unknown** ☐ Pipe Lined
Invert Depth: **30.31** (ft.) Flow Characteristics: **None**
Deposits: ☒ **None** ☐ Mud ☐ Sludge ☐ **Debris** ☐ Grease
Silt Depth: (in.) Deposits Extent:
Infiltration: **None** Pipe Seal Cond: **Sound**

Connects To: **Stub connection / abandoned**

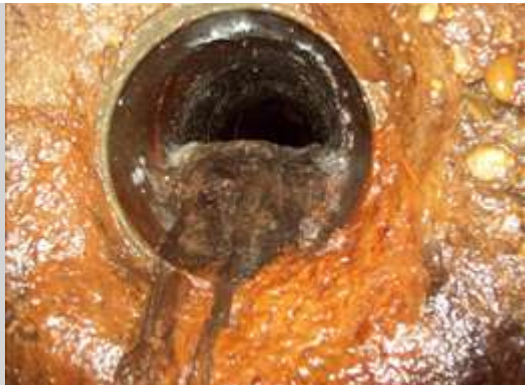
9 O'Clock Inflow

8 in. Circular Gravity Sewer

Pipe In @ 9 O'Clock

Pipe Material: **Clay** ☐ Pipe Lined

Infiltration: **None** Pipe Seal Cond: **Sound**
